## **Forensic Evaluation of Video Footage from the TIGHAR 2010 and 2012 Nikumaroro Expedition- Supplemental Report**

By: John D. Jarrell, PhD, PE

**February 28, 2014**

### **Supplemental Report**

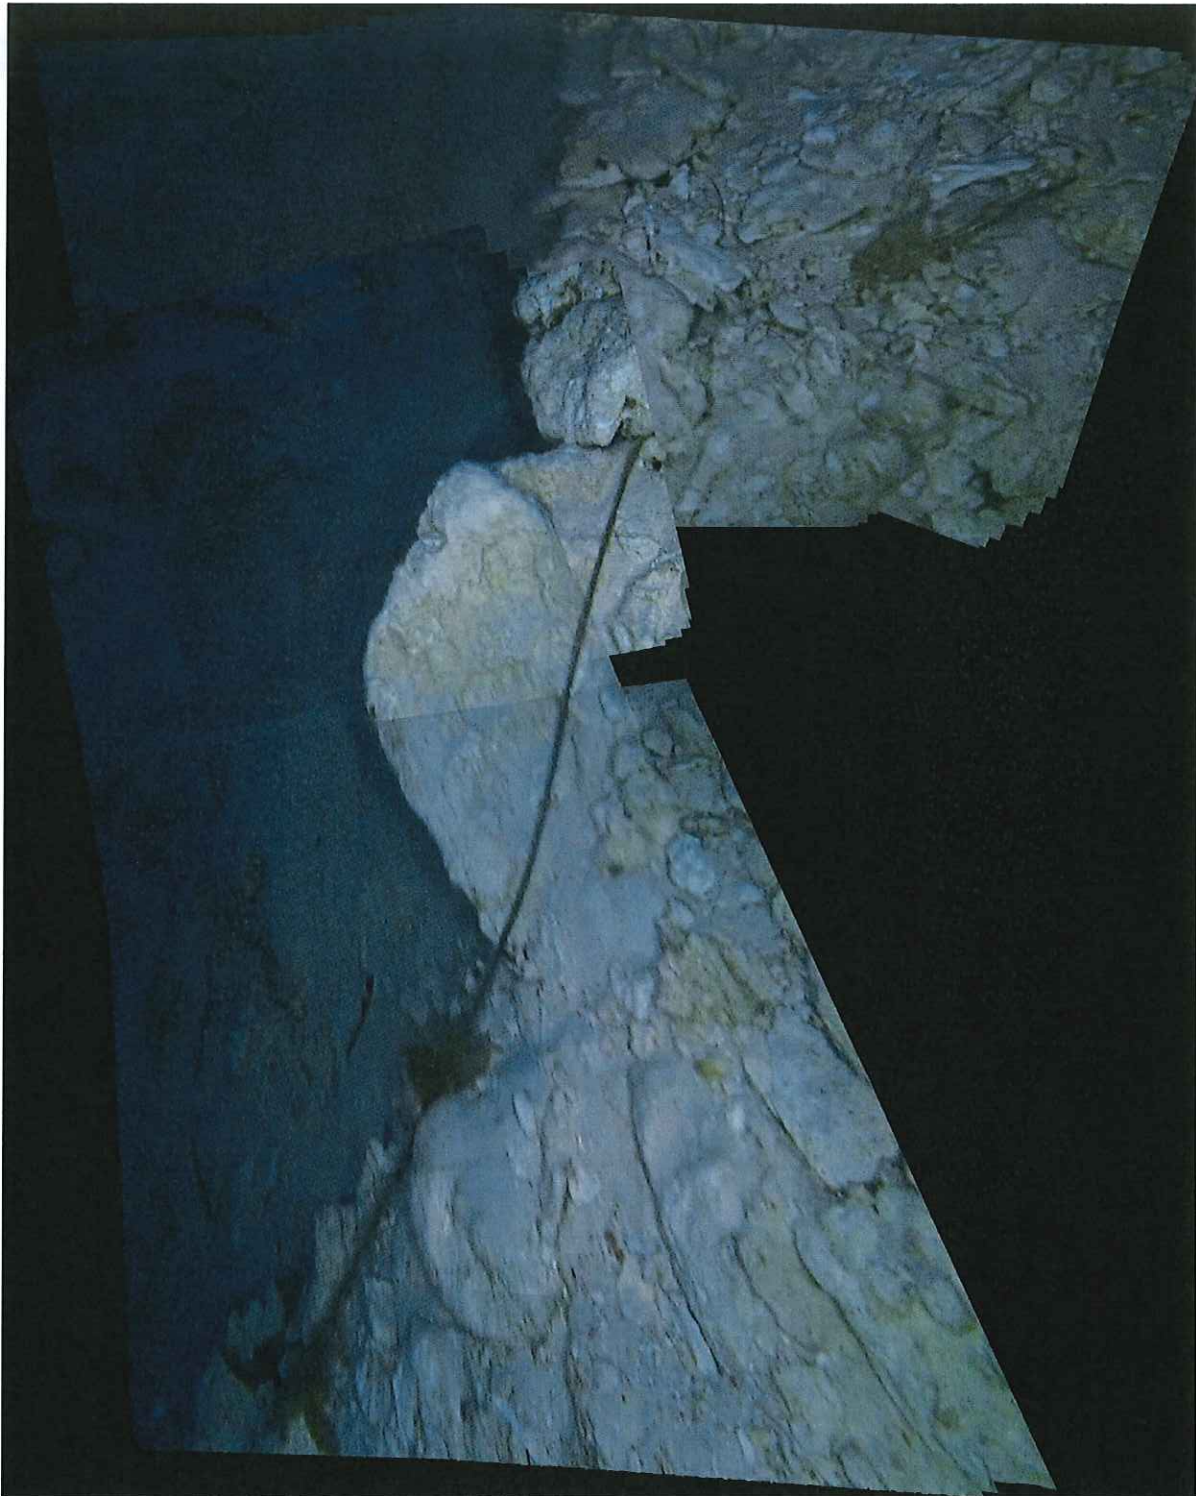
- 3) There is a collection of objects atypical of naturally occurring formations in some details of shape and coloration, but consistent with the front landing wheel, worm gear and strut assemblies; This object was determined to be more likely man-made than a naturally occurring formation. Our observation from the 2010 video are consistent with representation made in the TIGHAR bulletin concerning the 2012 video, where it states, "We have located a man-made debris field that is in the location that was expected and for which the shapes of the objects in the debris field are consistent with the object(s) seen in the Bevington image." <sup>ii</sup>;

Figure 1: This composite image from the 2010 1920x1080 rover footage, created by Fatih Calakli, illustrates the proximity of the front and rear landing gears.

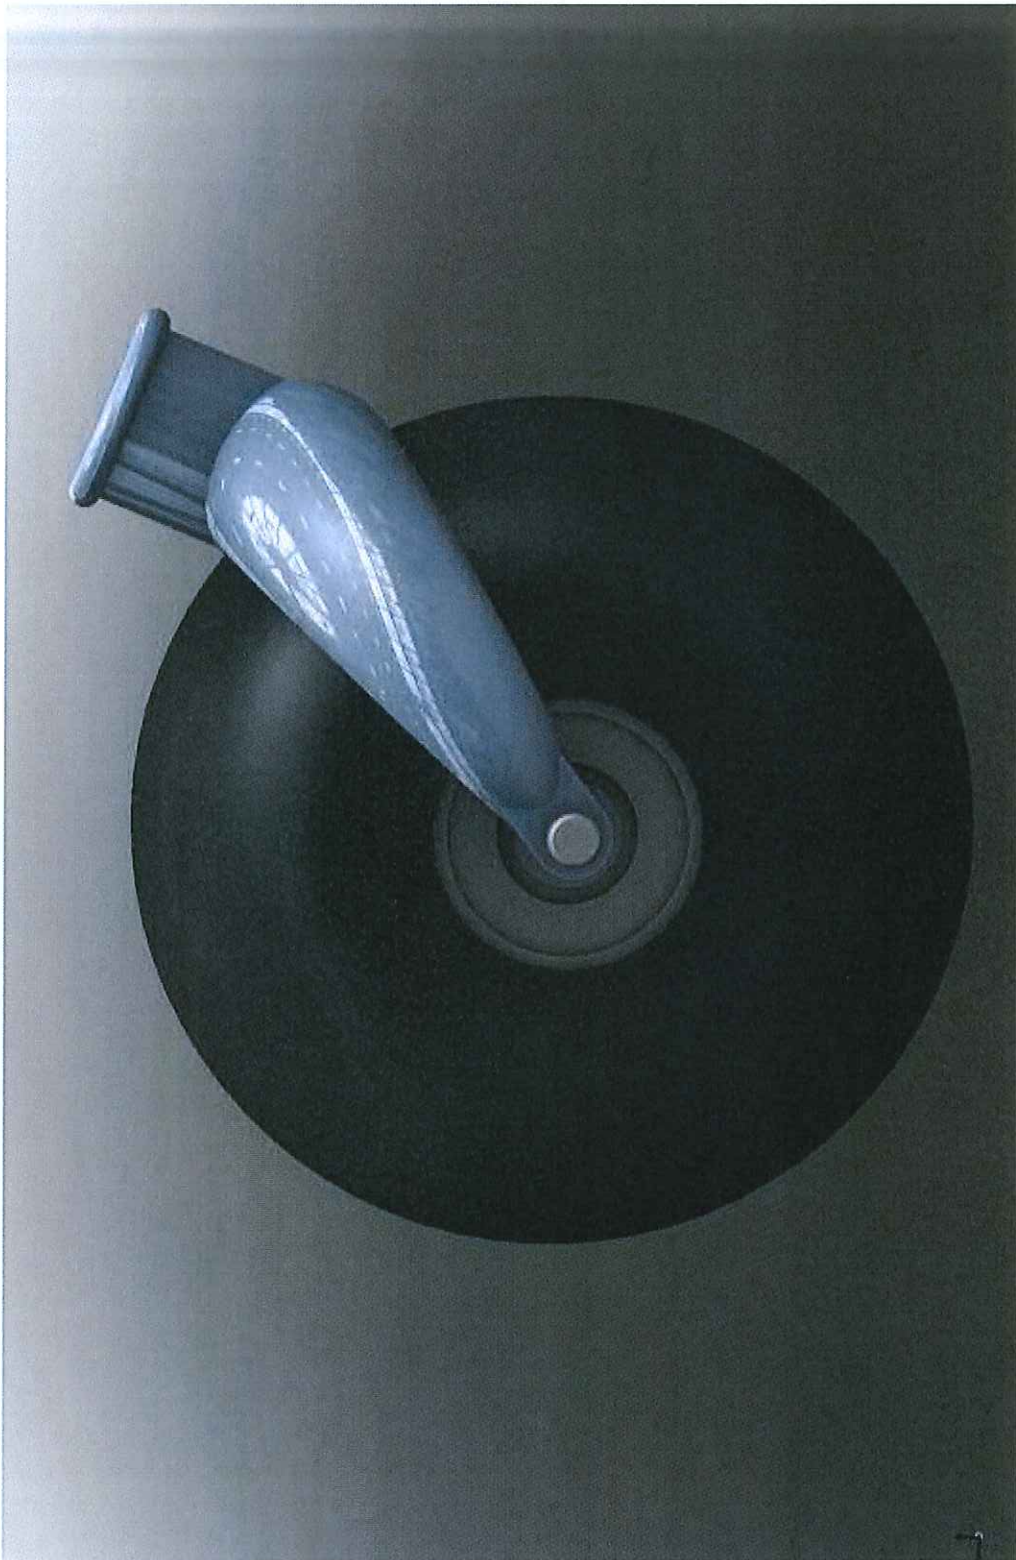
The front and rear landing gear assemblies were modeled using computer aided design (CAD) according to historical photographs taken of Amelia Earhart's Electra Model 10E aircraft, measurements taken from Grace McGuire's Electra 10 aircraft, and tire information from Earhart's aircraft inspection (Figure 3). The CAD models were overlaid on the 2010 1920x1080 rover footage and fit using a perspective view. Two plausible fits for the tailwheel are shown. Using the dimensional information available in the CAD model and the assumption that the wire was on the same plane as the bottom of the CAD assemblies resting on the sea floor, the wire was calculated to have an average width of 0.72" with a combined standard deviation of 0.06" for the tailwheel and an average width of 0.78" with a standard deviation of 0.05".

Figure 4: CAD model based on Earhart photo with 16 inch wheel (Earhart inspection report).

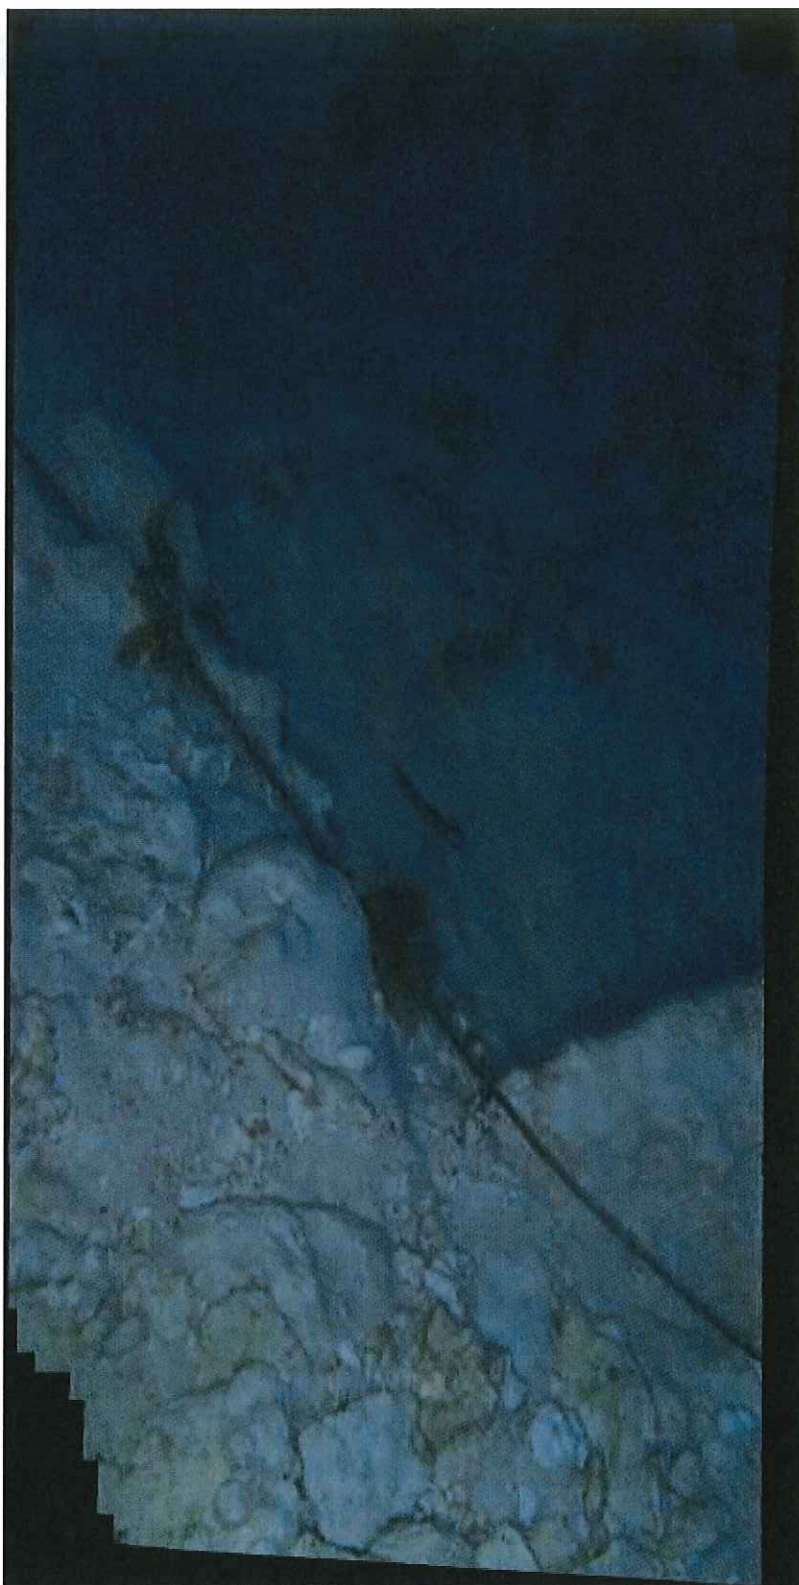
- 2) There is an object consistent in shape and geometry with a tailwheel as determined by geometric comparison with the tire and fork from a Lockheed Electra Model 10.

Figure 6: A composite image of the proposed rear landing gear from the 2010 1920x1080 rover video, created by Fatih Calakli; 33737.png.

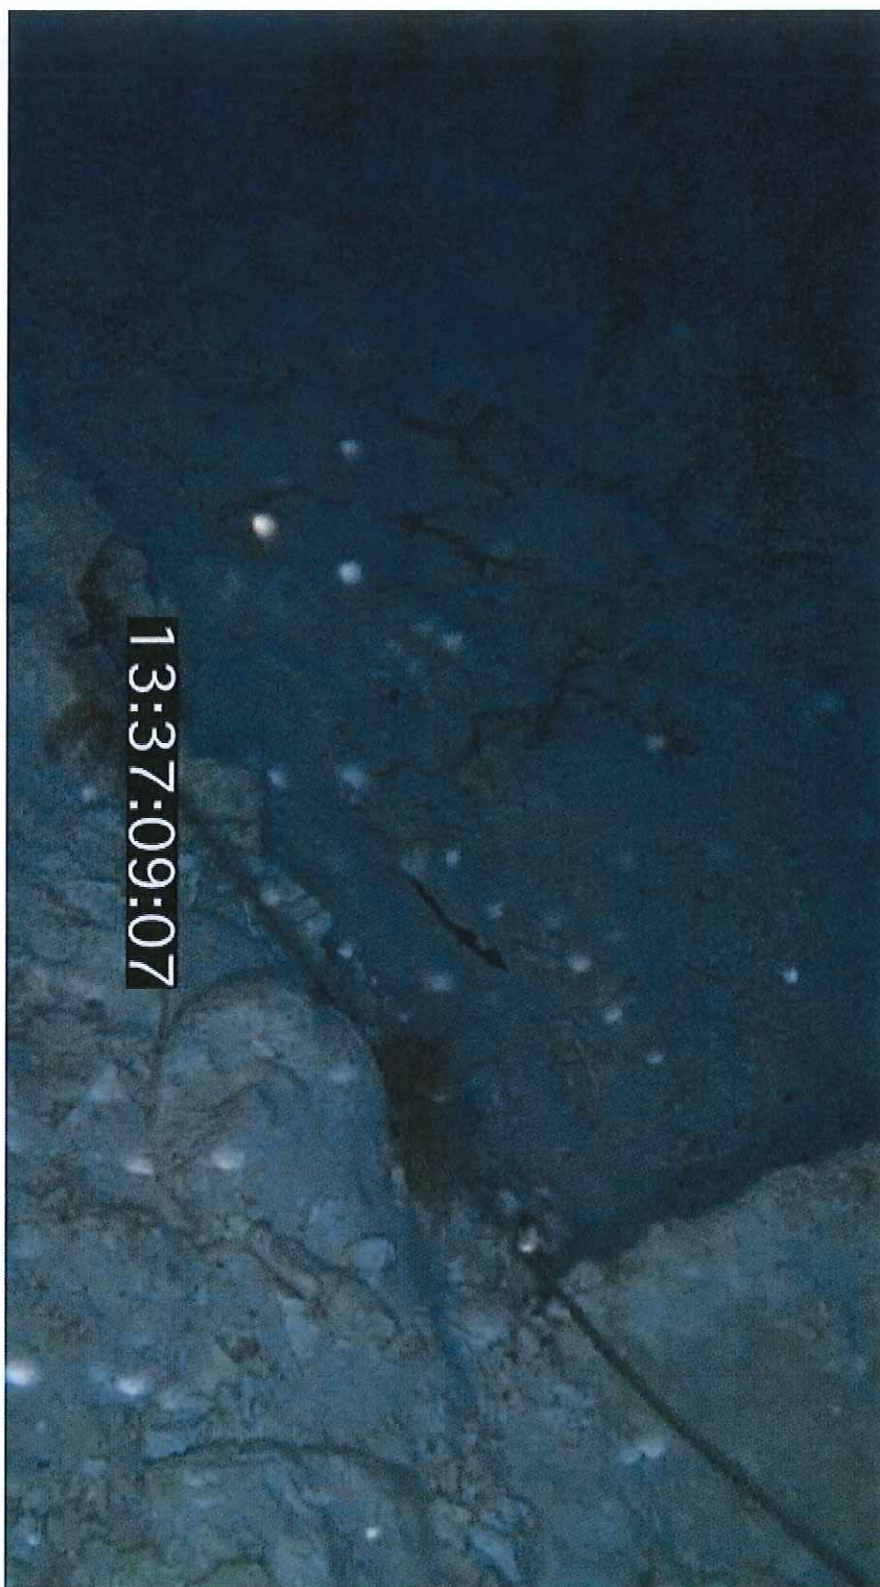
Figure 7: Still image of the proposed tailwheel from the 2010 1920x1080 rover video.

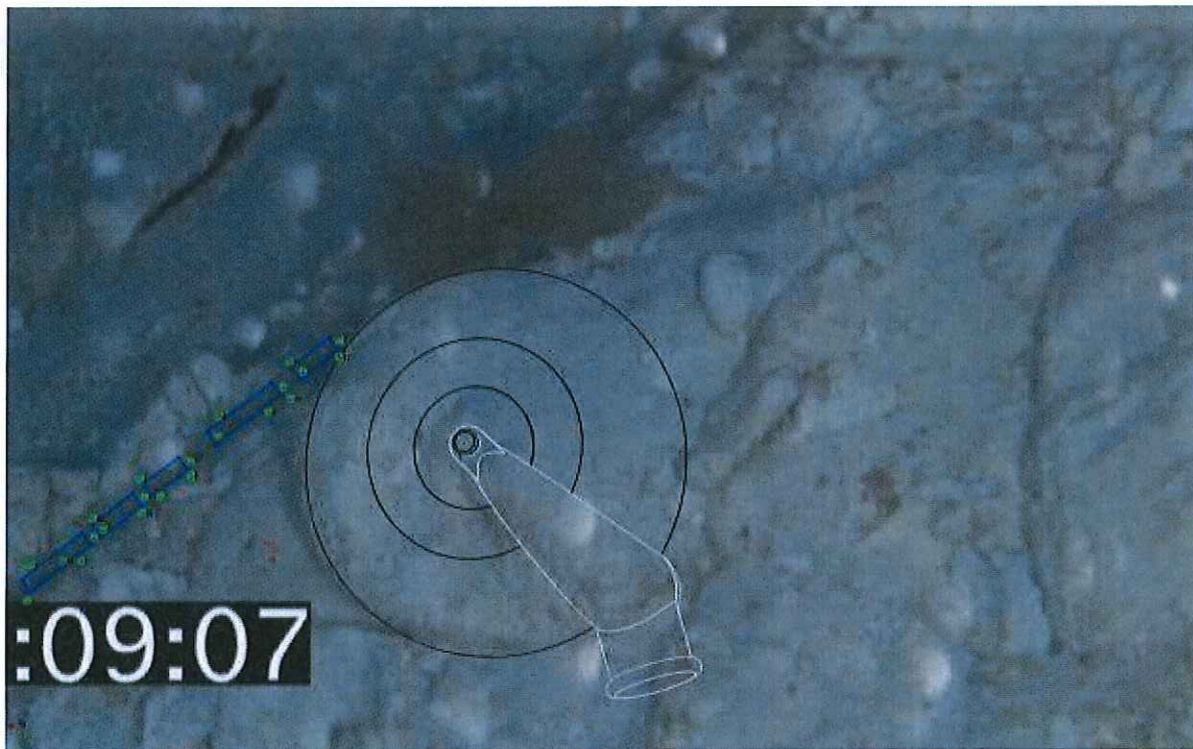
Figure 8: Five segments of the wire were bounded by rectangles, representing the cross-section of the rope. The rope was calculated to have an average diameter of 0.68" with a 0.01" standard deviation based on the CAD model of the tailwheel.

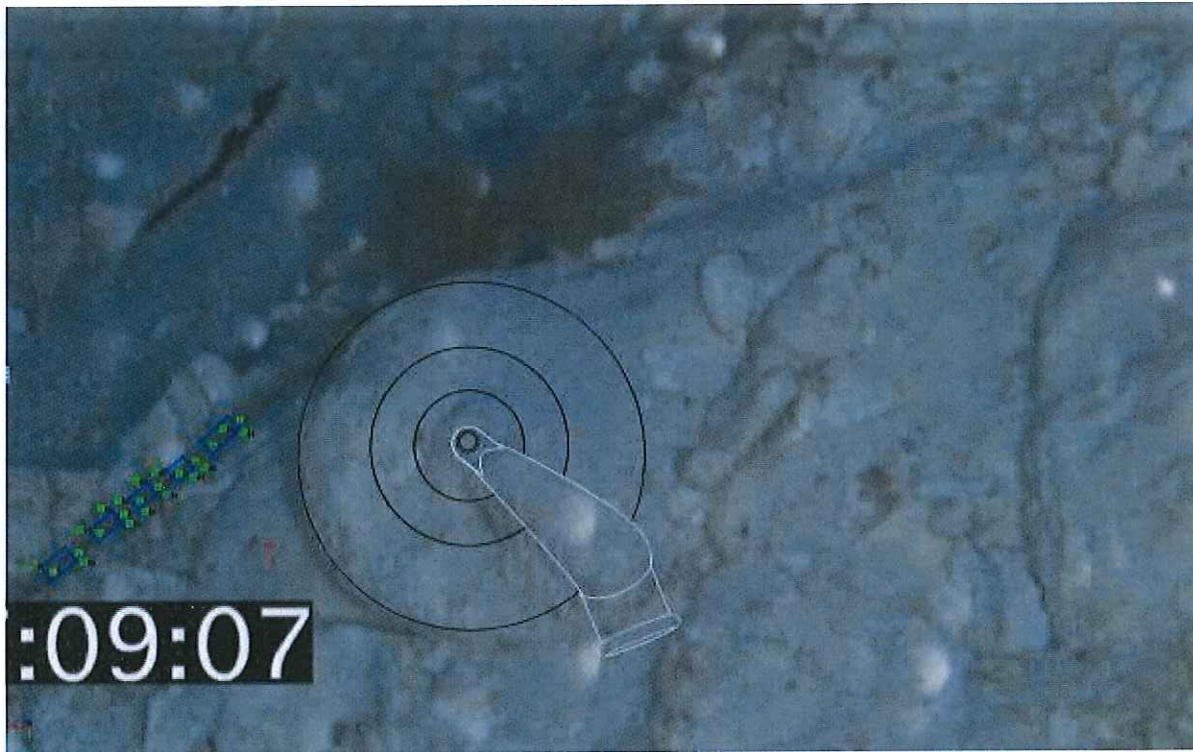
Figure 9: Five segments of the wire were bounded by rectangles, representing the cross-section of the rope. The rope was calculated to have an average diameter of 0.76" with a 0.07" standard deviation based on the CAD model of the tailwheel.
